Situation Photo Log

Tuesday, February 5, 2013

Kalamazoo River / Enbridge Spill

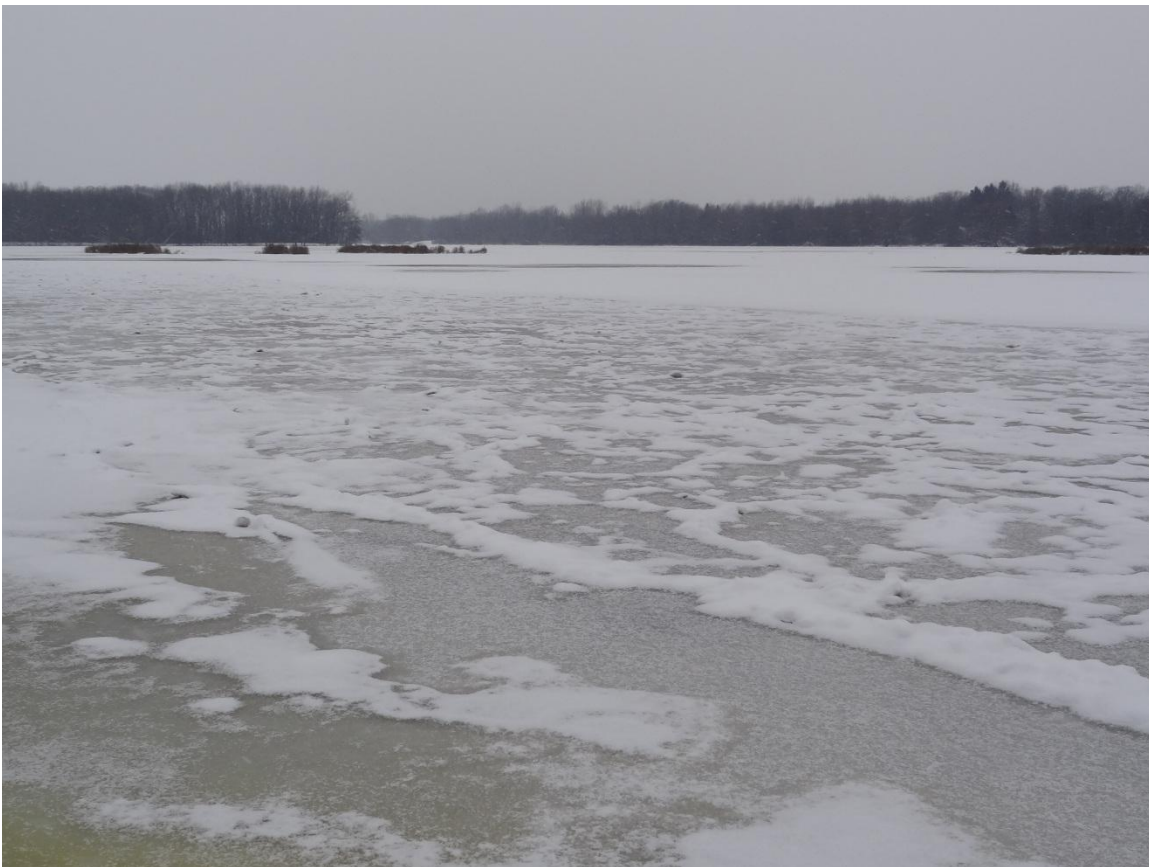
24. Morrow Lake Delta observed icing conditions.

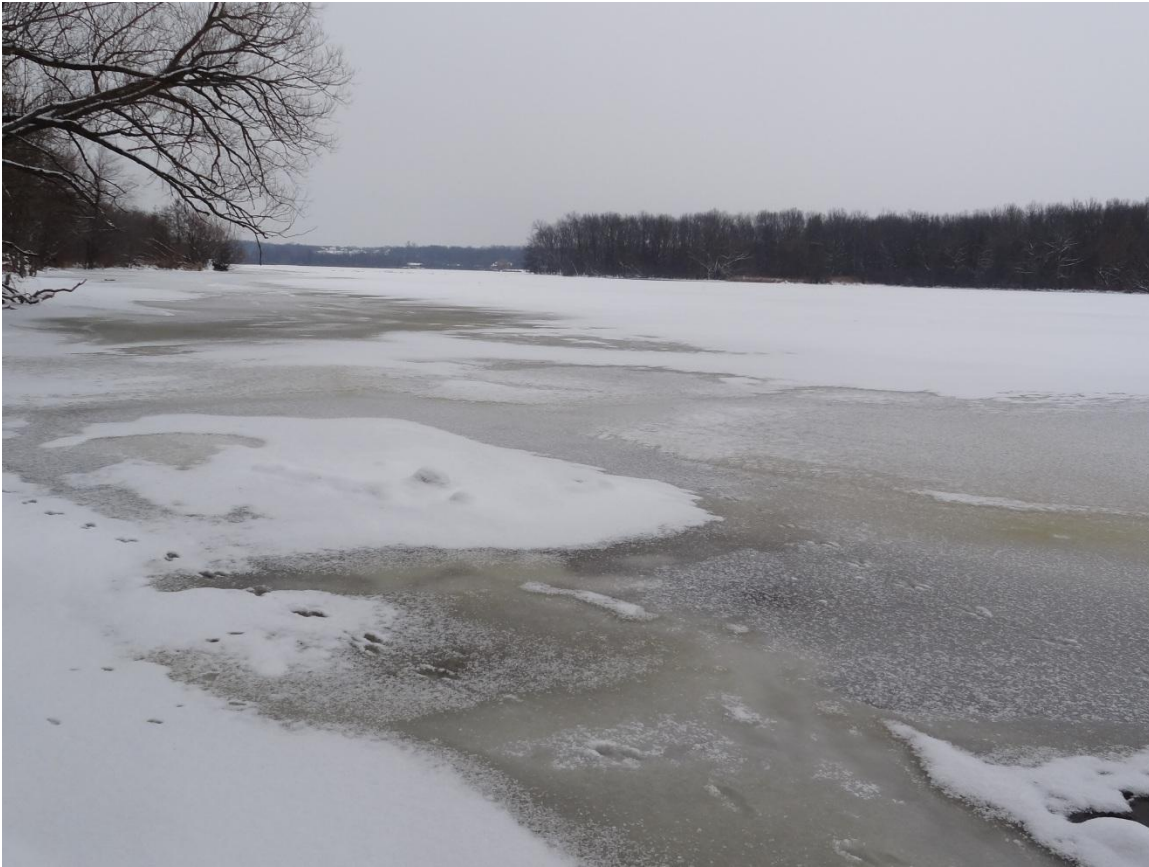
25. Morrow Lake Neck/Morrow Lake Delta observed icing conditions.

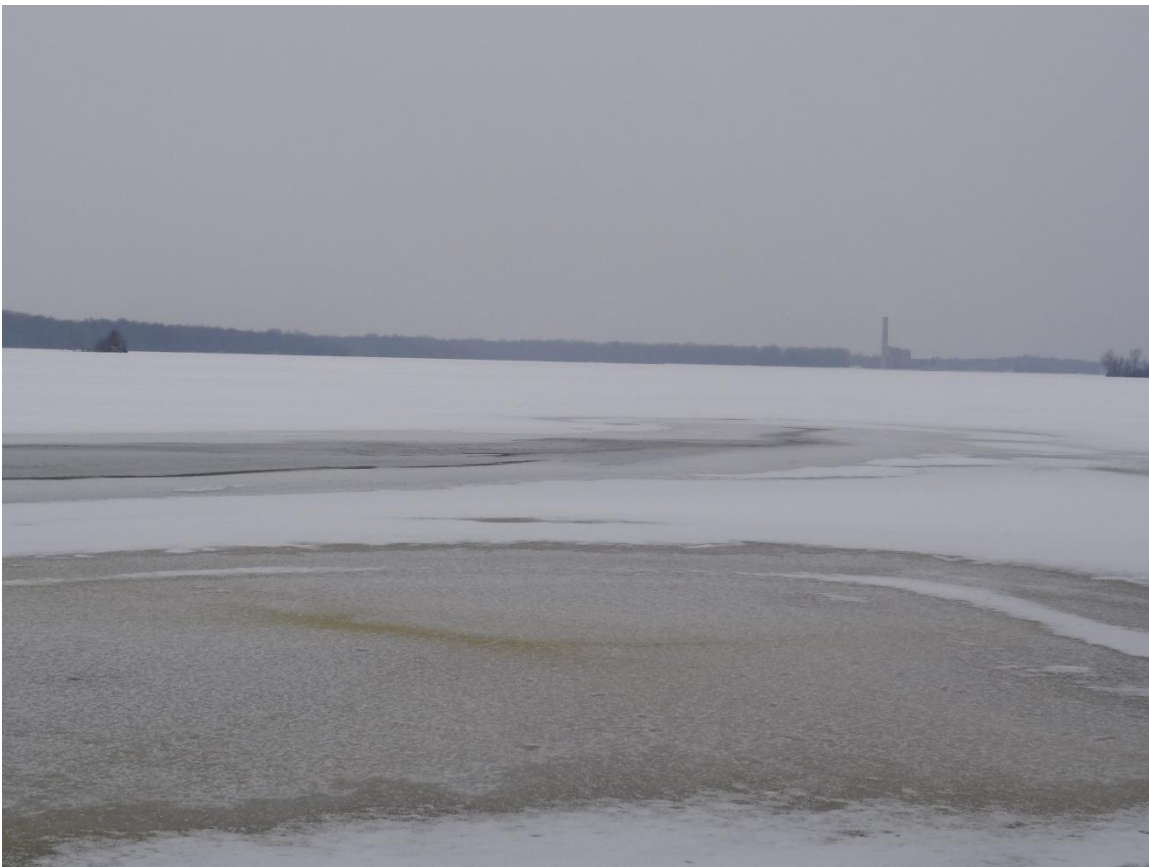
26. Morrow Lake observed icing conditions.
